MOBILE OFFSHORE DRILLING UNIT (MODU) OCEAN RANGER,
O.N. 615641, CAPSIZING AND SINKING IN THE ATLANTIC
OCEAN ON 15 FEBRUARY 1982 WITH MULTIPLE LOSS OF LIFE

1. Report No. USCG 0001 HQS 82		2. Government Accession No. AD-A140 910		3. Recipient's Catalog No.	
4. Title and Subtitle Marine Casualty Report Mobile Offshore Drilling Unit (MODU) OCEAN RANGER, O.N. 615641, Capsizing and Sinking in the Atlantic Ocean on 15 February 1982 with multiple loss of life				5. Report Date 20 May 1983

**REPORT OF THE U.S. COAST GUARD
MARINE BOARD OF INVESTIGATION CONCERNING
THE MODU OCEAN RANGER, O.N. 615641;
CAPSIZING AND SINKING IN THE ATLANTIC OCEAN
ON 15 FEBRUARY 1982 WITH MULTIPLE LOSS OF LIFE**

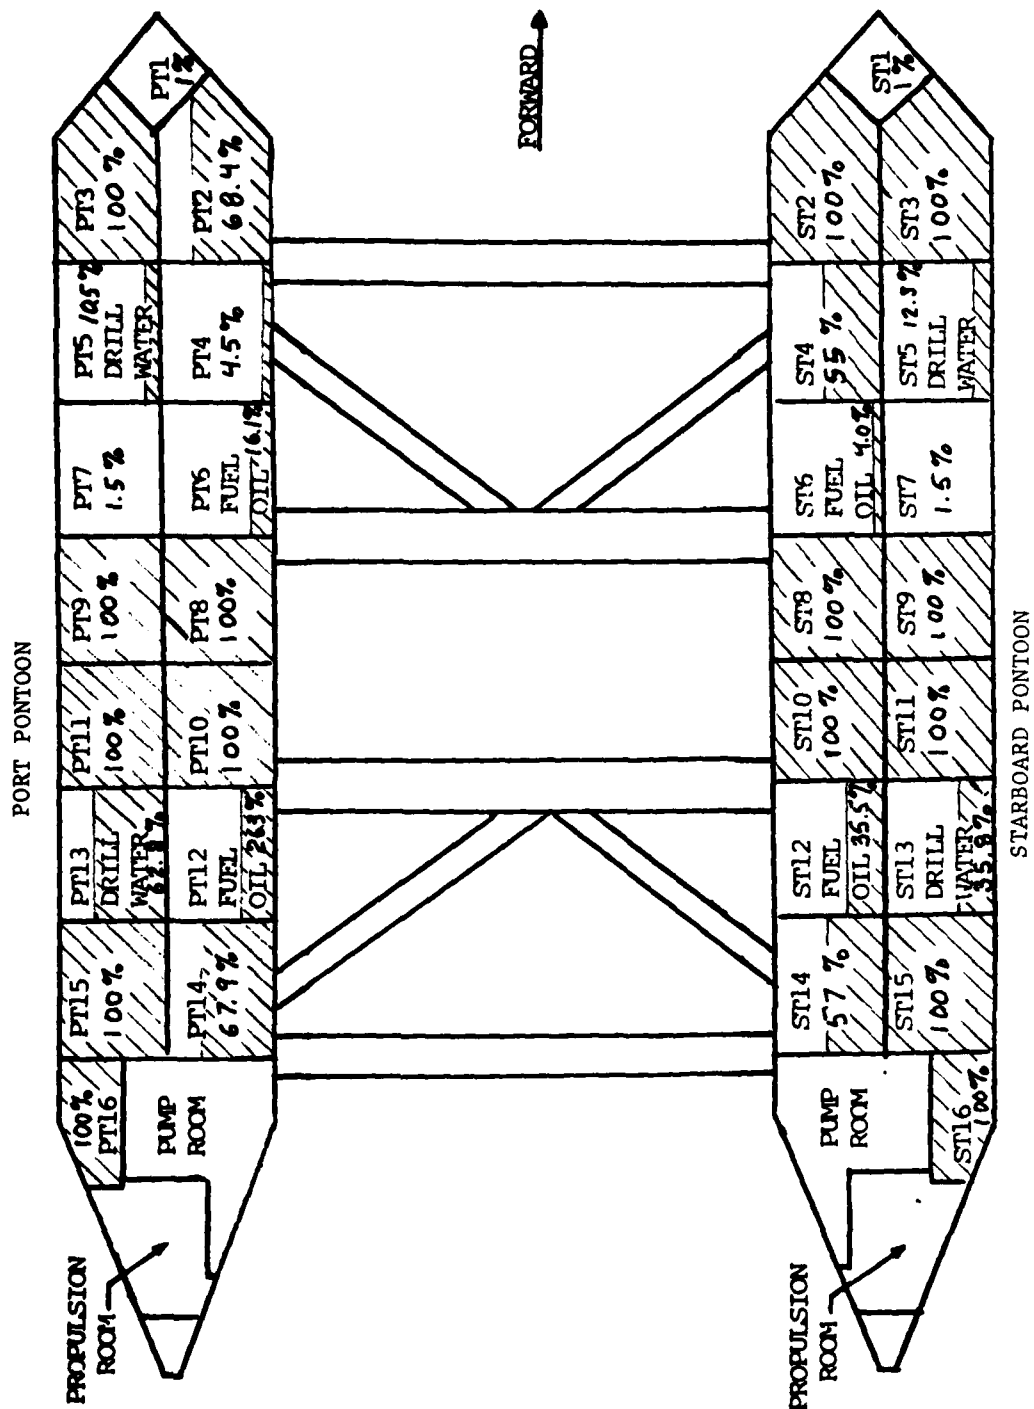
Figure 15: PERCENTAGE OF LIQUIDS IN OCEAN RANGER PONTOON TANKS,
MORNING OF 14 FEBRUARY 1982

Figure 15 depicts the liquid levels in the ballast tanks on 14 February 1982 as indicated in the weekly ballast report work sheets recovered from the OCEAN RANGER. The report indicated that the after ballast tanks used for adjusting trim, PT 14 and ST 14 were respectively 67.9% and 57.0% of capacity. The ullage provided a potential moment to correct trim of 58,000 foot/long tons (F/LT). During the evening, the control panel was doused with sea water entering a broken porthole causing an actual or perceived panel malfunction. At the time of malfunction or when personnel attempted to correct the malfunction, the OCEAN RANGER either took water into the ballast tanks or water shifted to the forward tanks, or both, causing a list by the bow. At some point, the crew had taken the measure of closing the two manually operated sea inlet gate valves. Evidence indicates the rig may have had a 10 degree list for a period of time which the crew believed had stabilized. An approximate moment of 17,000 (F/LT) was required to cause a 10° trim by the bow.

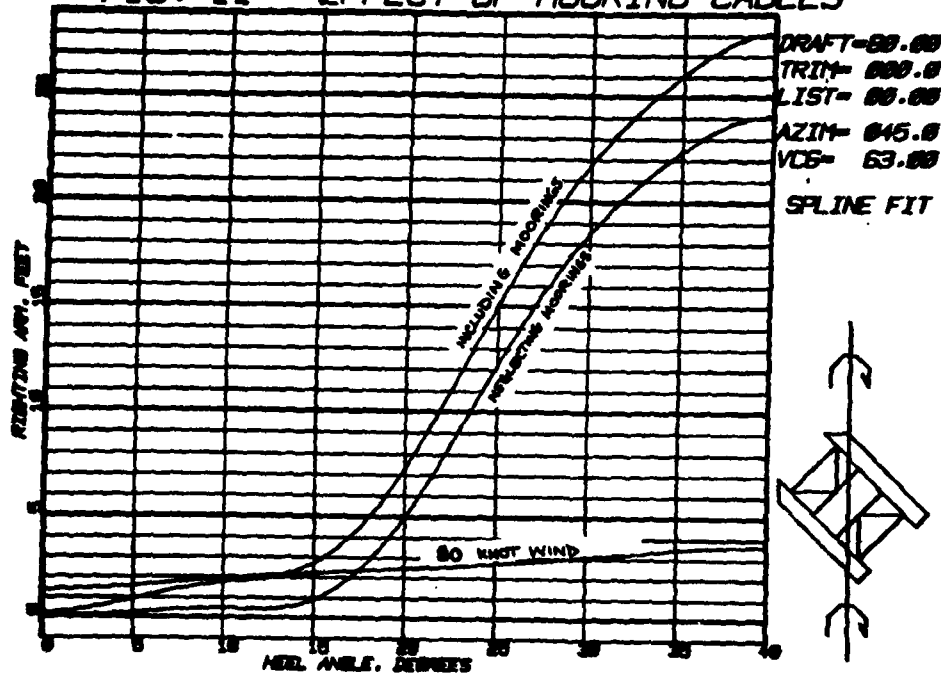
FIG. II - EFFECT OF MOORING CABLES

(5) The maximum calculated mooring line tension was less than 1/2 the breaking strength. The actual line tensions were much higher. This analysis neglected the additional mooring load due to increased wind overturning moment and lateral drag at large heel angles.

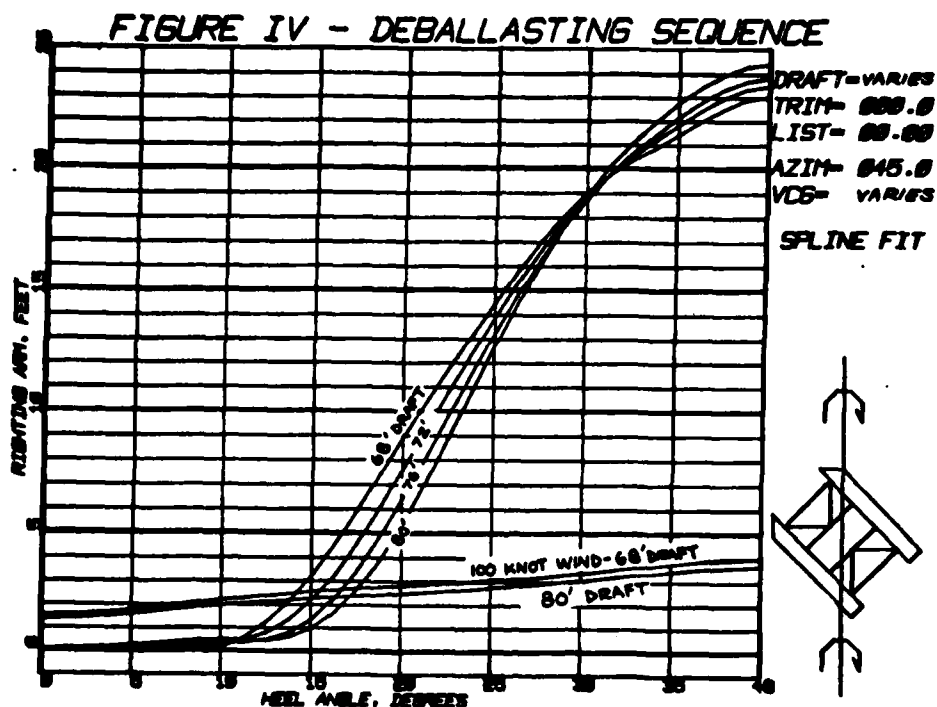
Task IV - Deballasting. Determine righting arms and wind heeling arms for various drafts as the unit is deballasted from the 80' drilling draft toward the survival draft. Use the operating manual deballasting sequence and investigate at 4 foot increments between 80 foot and 68 foot drafts.

(2) As the deballasting sequence progressed, the rig became more sensitive at heel angles less than 10°. Conversely, it became more stable in the range from 10°-30°, showing a reduced equilibrium heel angle under the influence of a 100 knot wind from the port bow.

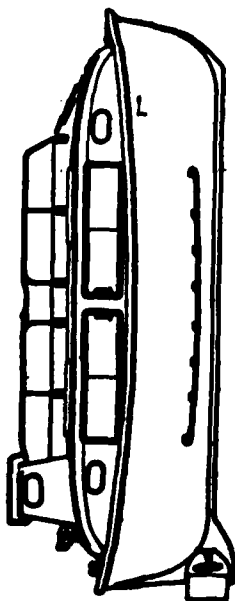
Figure 2d. The glassed in keel shoe is
unable to support the boat in this
position and is torn out, allowing the
release gear to separate from the boat
which enters the water stern first.

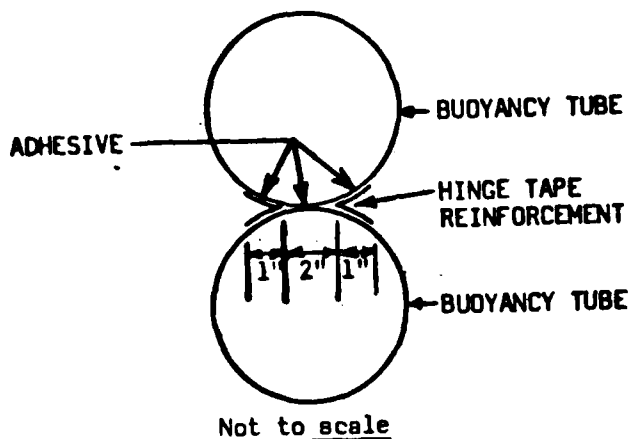
adhesive joining upper and lower tubes directly. Adhesive was evident only on the reinforcement. If the tubes are directly joined, forces tending to separate upper and lower tubes would be resisted by a tensile load on the adhesive joining the tubes. As built, the forces pulling the tubes apart are resisted by the reinforcing tape in the peel mode. If the tubes had been joined in the central area, the resulting structure may have been more resistant to separation.

Figure 3. Normal construction of liferaft.
